Water Compliance Inspection Report

**NPDES
Inspection Report**

TJ Veen Acre Farms, Inc.

March 31, 2010

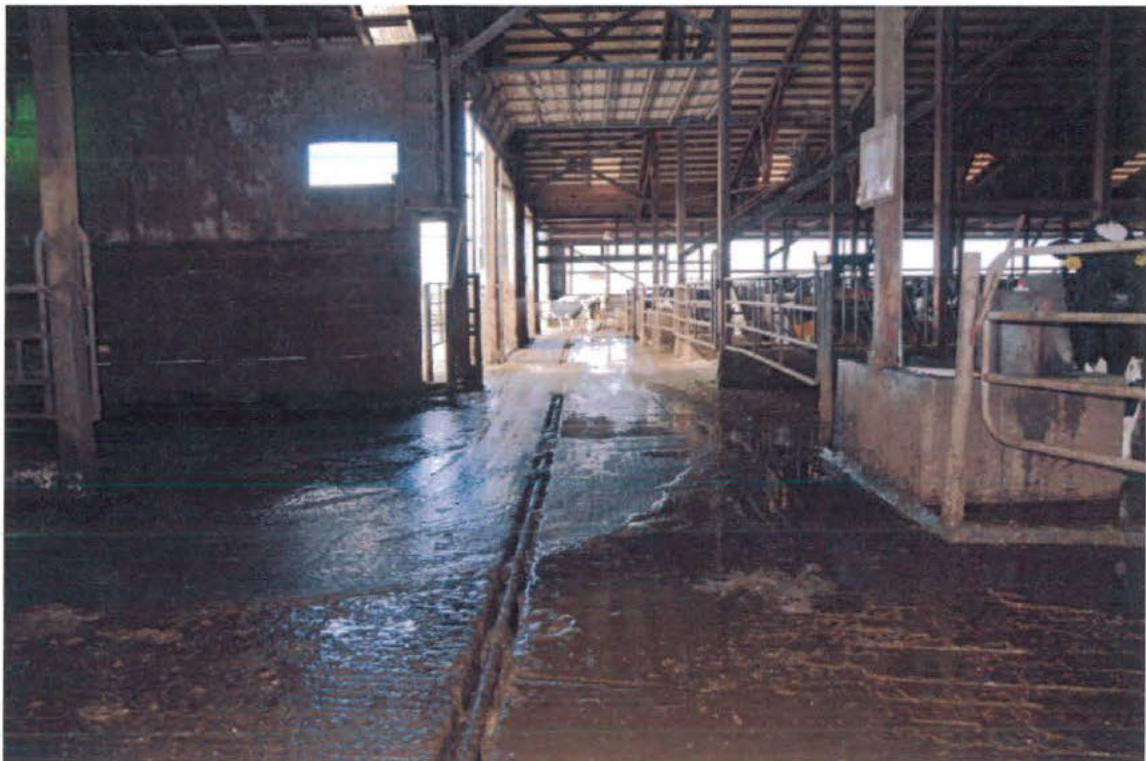
Photo #2: Westerly view showing a portion of the confinement area.

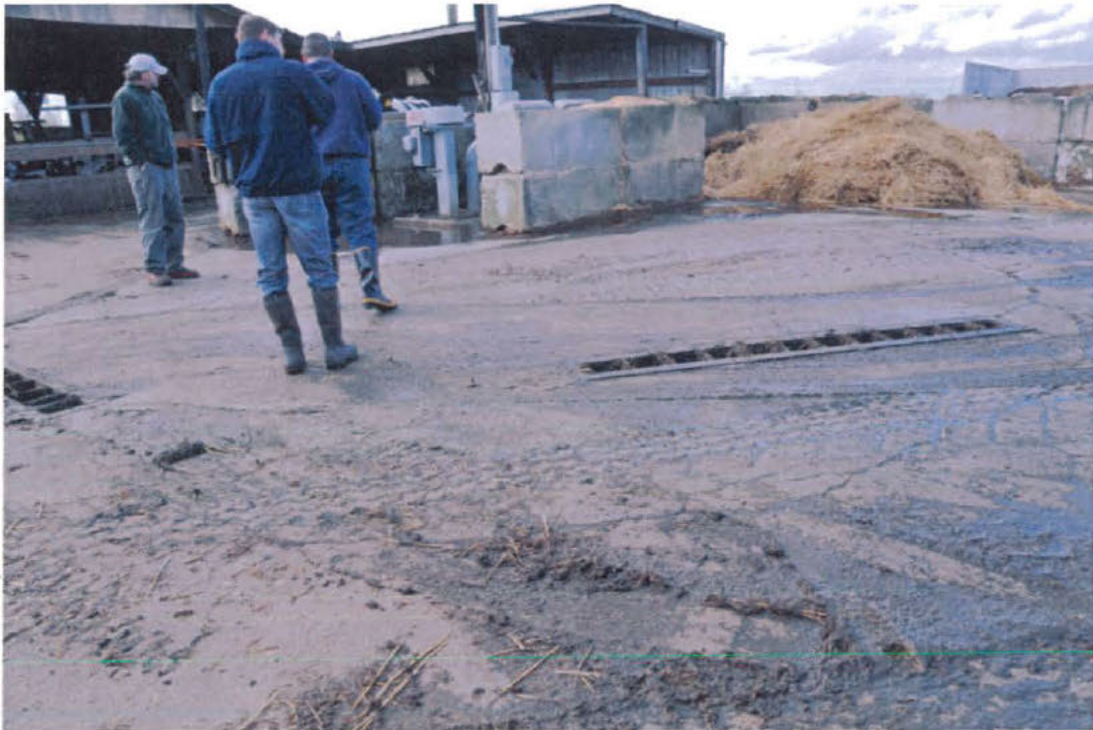
Photo #3: View in the vicinity of the below ground manure pit.

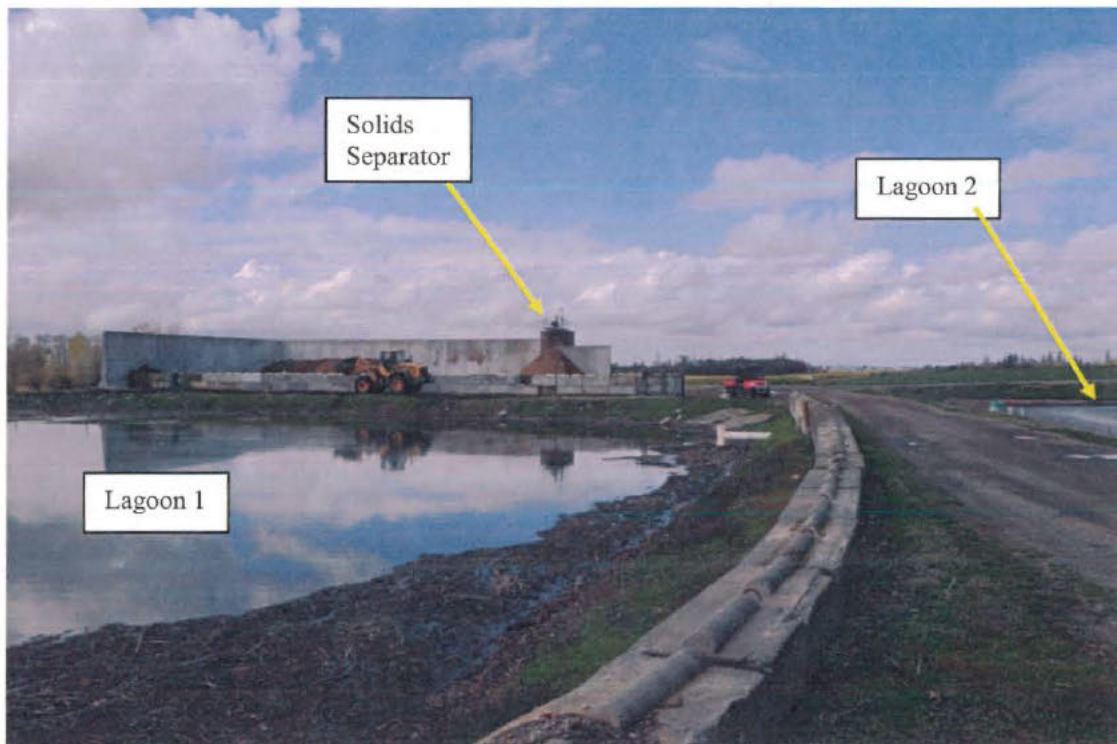
Photo #4: Westerly view showing stage one of the lagoon system on the left and stage two on the right. Also note the solids separator in the background.

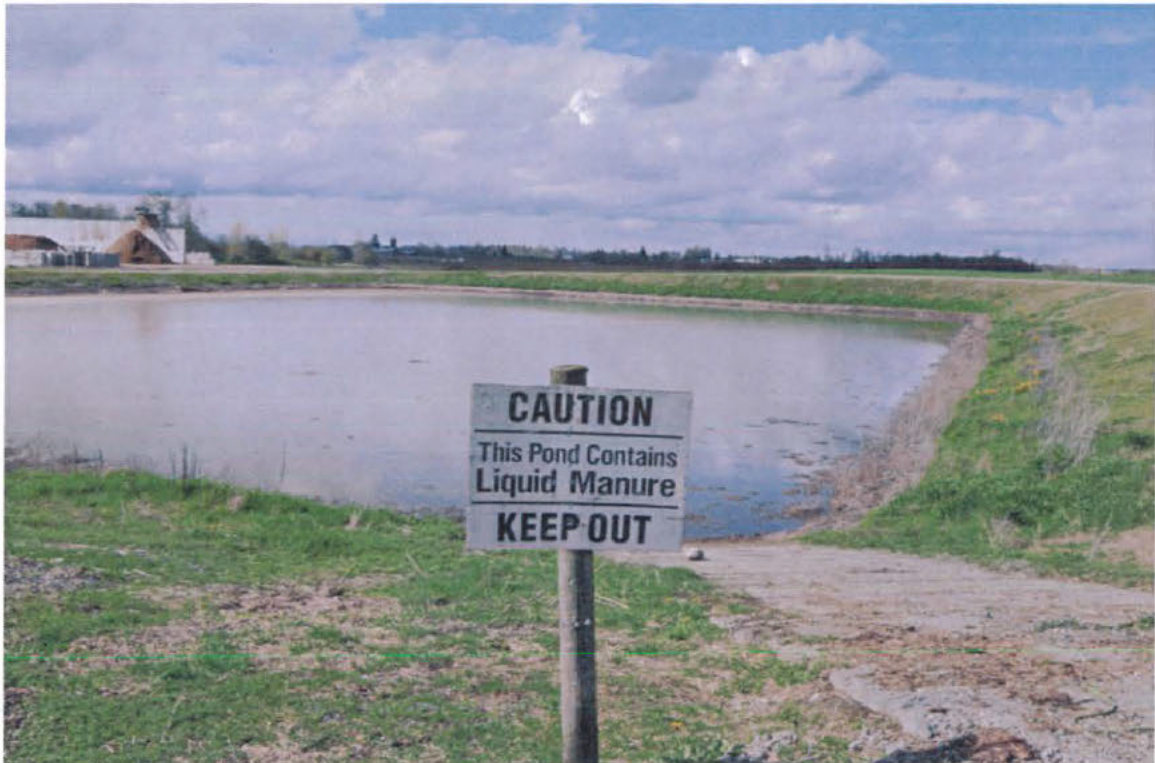
Photo #5: Southwesterly view showing the stage two lagoon.

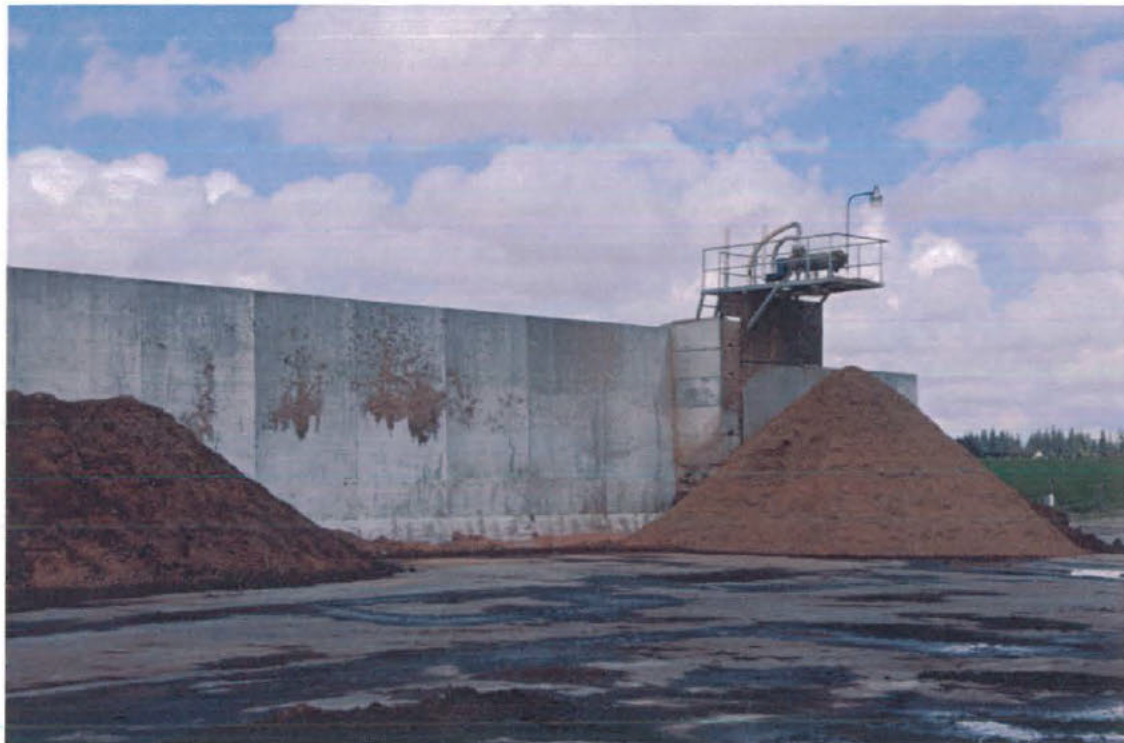
Photo #6: Close-up of the solids separator.

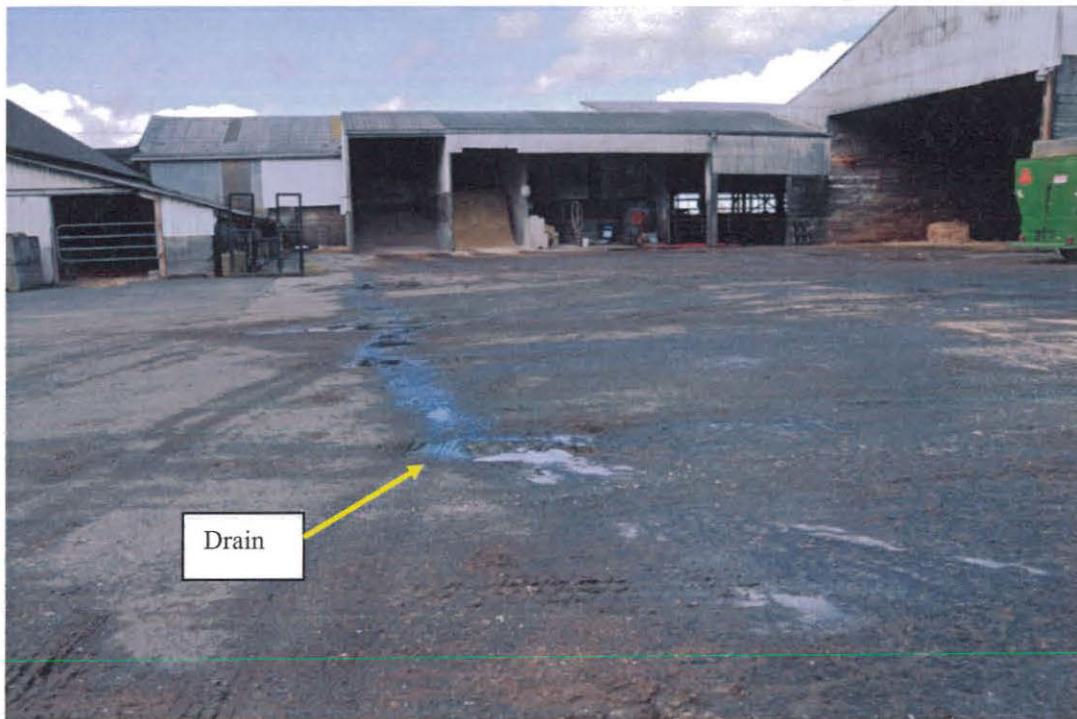
- A. Silage Leachate Drainage While inspecting the dairy barn complex I inspected the vicinity of the silage bunker. I saw that the area just south of the silage bunker appeared to slope toward a drain located south of the silage bunker and east of the milk parlor. I also saw what appeared to be residual silage in this drainage area. See photograph #7 of attachment B and attachment C for details of this silage drainage.

Photo #7: Westerly view in the vicinity of the silage bunker which is located to the right of this photograph. Note the drain in the center which collects drainage from this area of the facility.

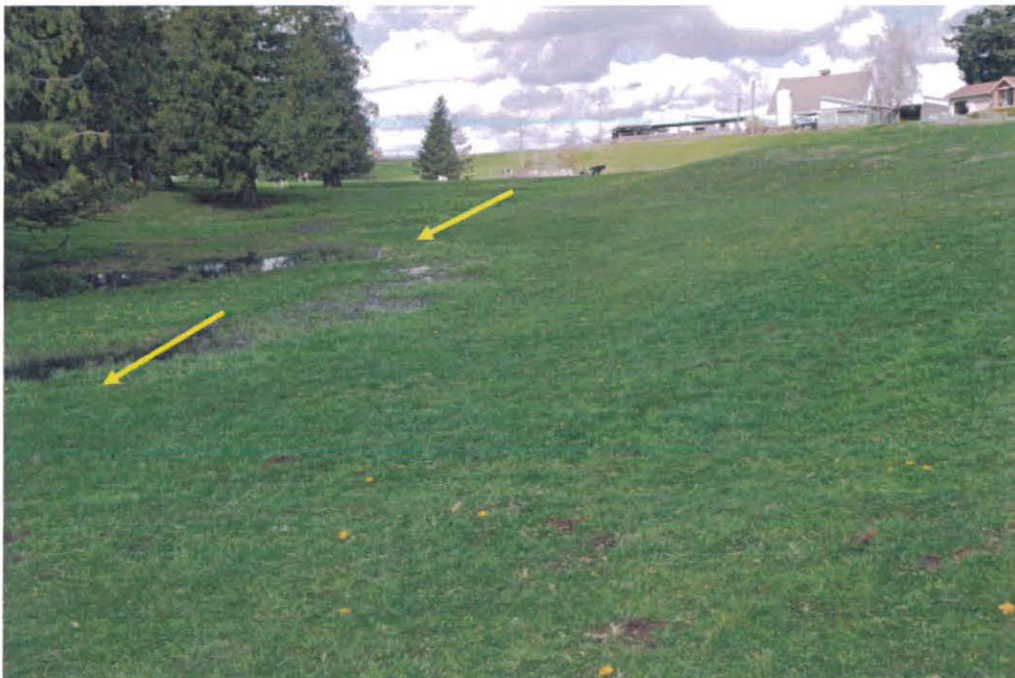
According to Mr. Vander Veen, wastewater entering this drain is routed south of the dairy via an underground pipeline. The outlet end of this pipeline daylights south of the dairy in an area identified as a filter strip. See photograph #s 8 and 9 of attachment B and attachment D for details of this filter strip.

Photo #8: Northerly view showing the dairy barn complex in the background and the filter strip area identified by the yellow arrows. This filter strip receives the drainage from the portion of the dairy shown in the previous photograph.

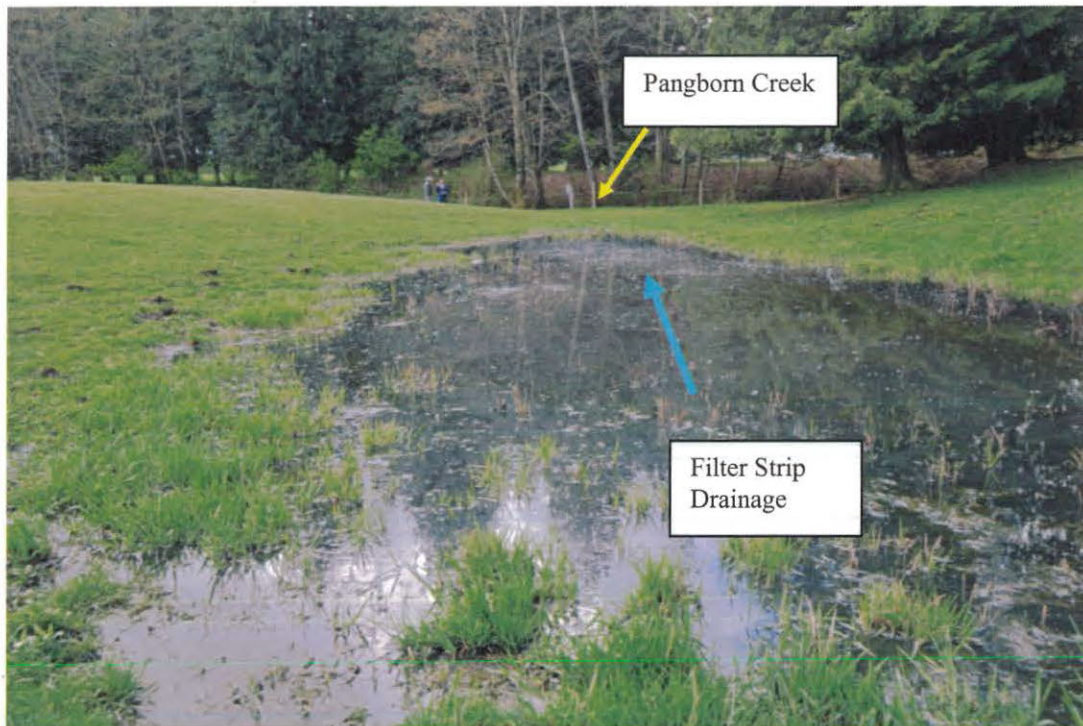
Mr. Vander Veen said that water flowing into this filter strip does not flow into Pangborn Creek because the filter strip is blocked off before getting to the creek. However, upon inspection of the area I saw an eroded channel leading from the end of the filter strip to Pangborn Creek.

Although I did not see a discharge from the filter strip to Pangborn Creek at the time of the inspection, the concern is that silage drainage entering this filter strip has the potential to enter Pangborn Creek during certain rain events.

Photo #9: Another view of the filter strip drainage. This photograph was taken further south from the dairy than the previous photograph. Note that Pangborn Creek is located along the row of trees in the background of the photograph.

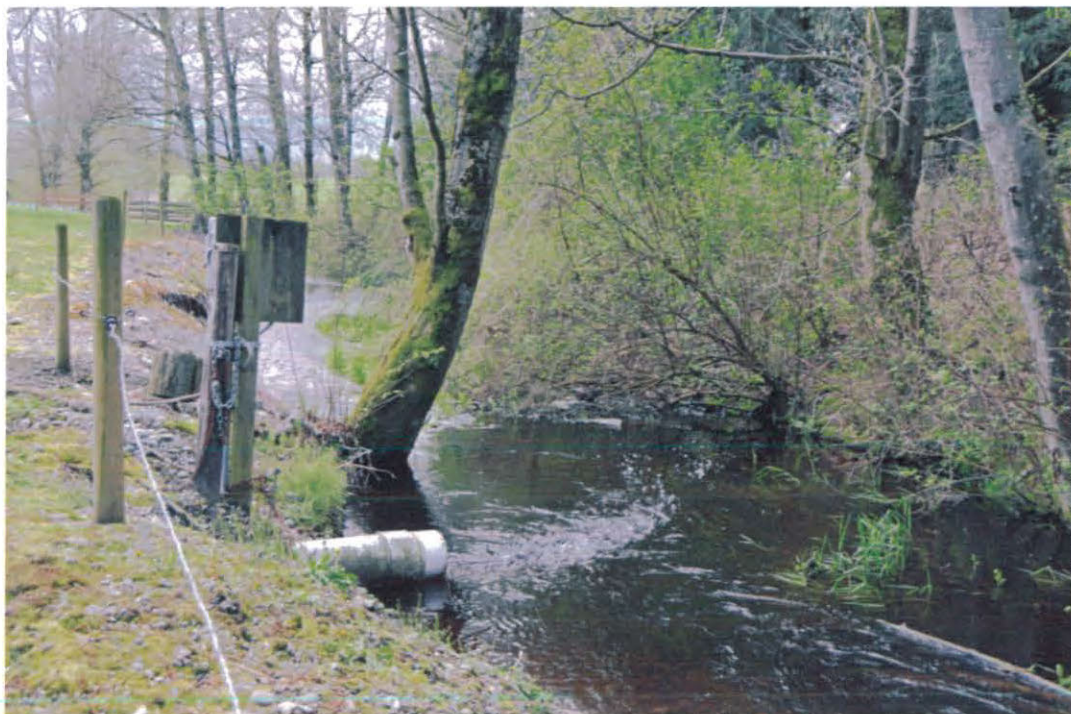
I saw that this filter strip area appeared to slope in the direction of Pangborn Creek which is located south of the dairy barn complex. See photograph #10 of attachment B and attachment D for details on Pangborn Creek.

Photo #10: Easterly view showing Pangborn Creek. Note that the pooled liquid from the filter strip is to the left of this photograph.

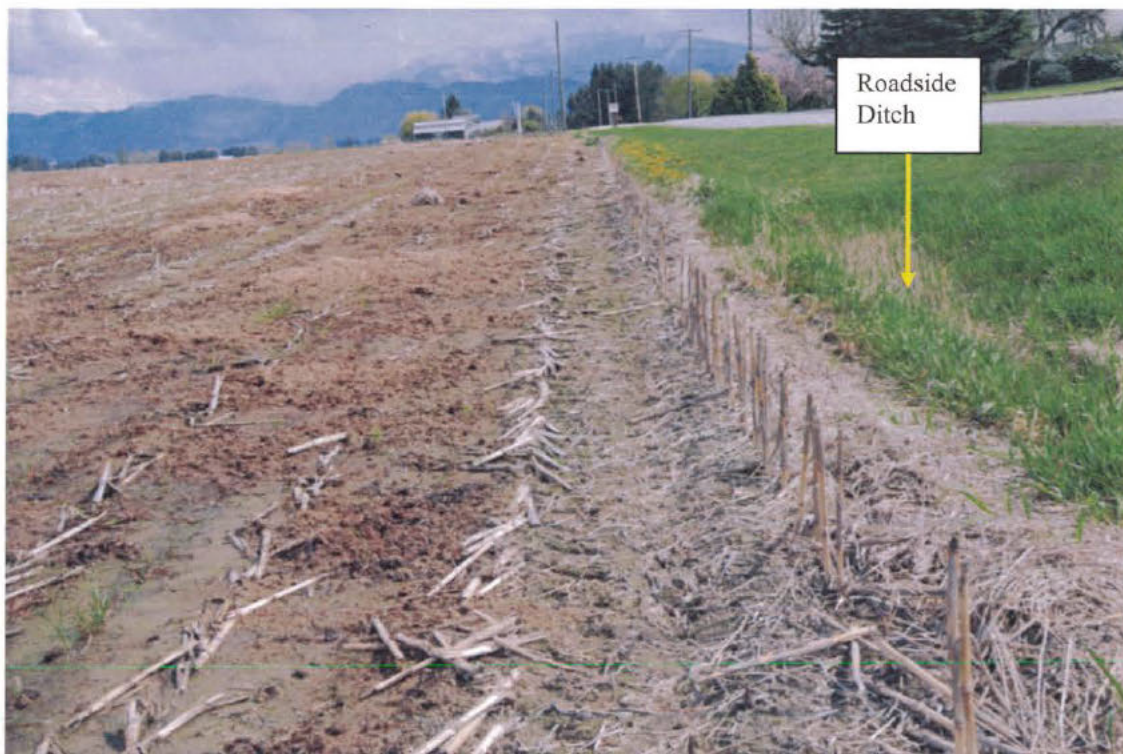
- B. Land Application Along Clearbrook Road At the time of the inspection, we inspected a land application field located along Clearbrook Road. The vegetation on this field was corn stubble. I saw that manure solids were applied to portions of this 39.7 acre field. I also saw that in portions of the field manure solids were applied approximately five to ten feet from drainage ditches located along the edge of this land application field. See photograph #s 11 and 12 of attachment B and attachment E for details of this land application field.

The concern is that the distance between the edge of the manure application and the nearby drainage ditches appears to be closer than the buffers established in the facility's nutrient management plan.

I did not see runoff from this land application field enter nearby drainage ditches at the time of the inspection. However, I did not see any mechanism in place on this field to prevent runoff from entering these drainage ditches. Another concern is that runoff could enter these drainage ditches during certain rain events.

Photo #11: View of applied solids along Clearbrook Road. Note that these applied solids are within five to ten feet of the roadside ditch on the right side of the photograph.

* Please address areas in field ISA and ISB where solids were applied to close to ditches. Place earthen berm between solids and ditch.

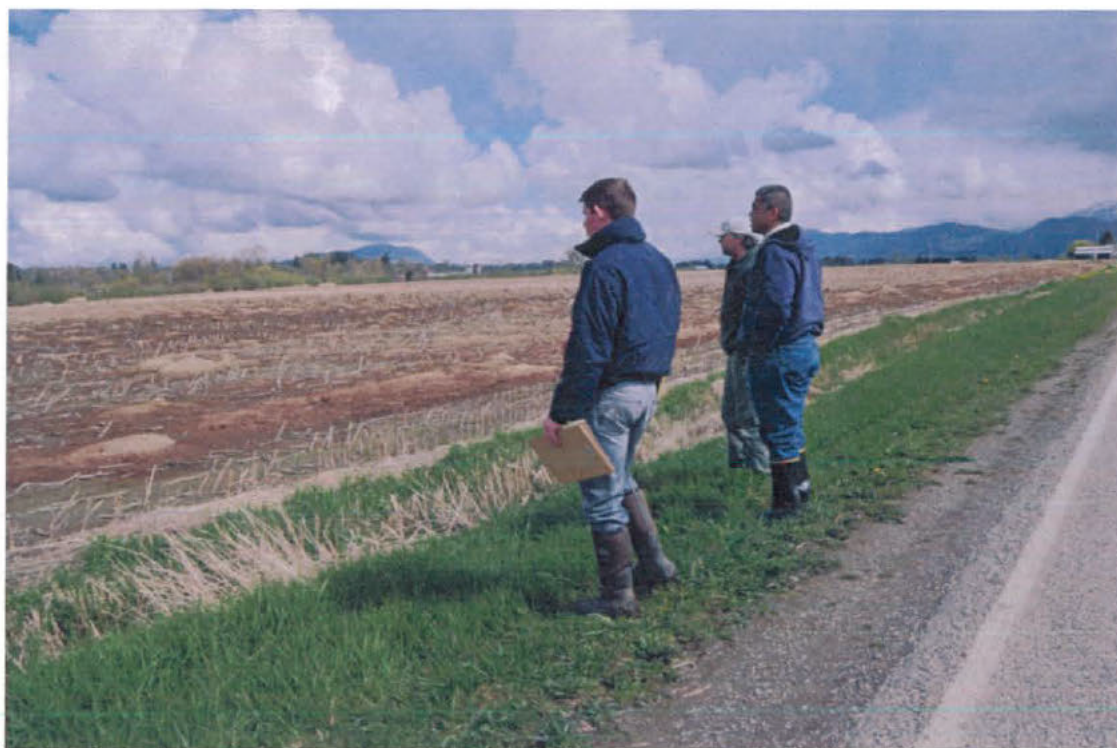
Photo #12: Another view of the land application field along Clearbrook Road.
